Spatial Analysis of Dry Valley Floods in Salah Al-Din Governorate and Ramadan Valley

Keywords: Dry Valley Floods; Salah Al-Din Governorate; Ramadan Valley.

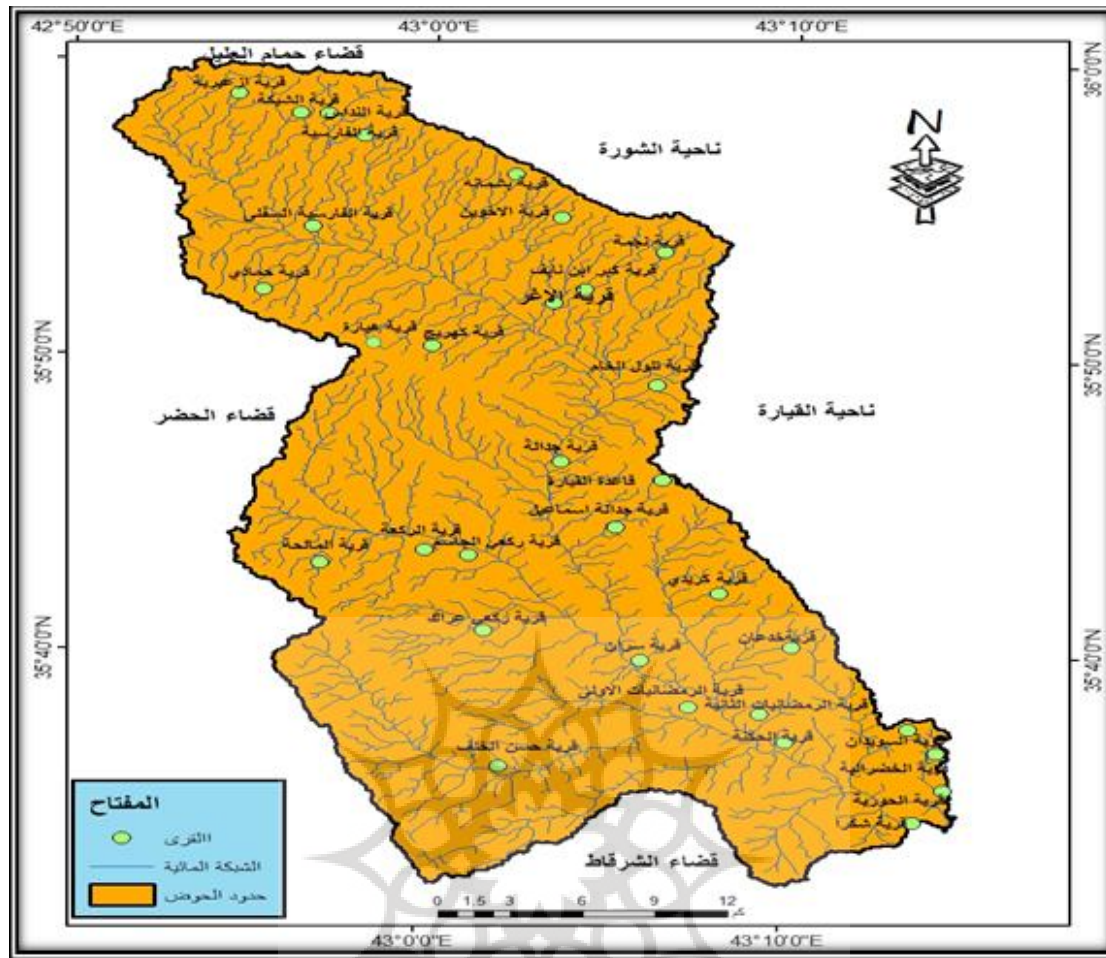
Map 2. Human settlements in the study area

The studied human settlements belong to the district of Shirqat within Salah al-Din governorate within four villages threatened by flooding, Qura Al-Houriya, Al-Khadraniya, Al-Eitha and Shukran villages. 500 to 1000 meters downstream.

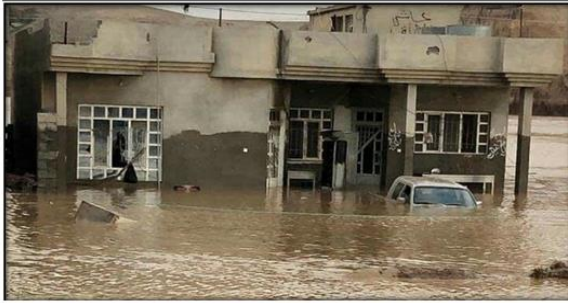
Picture 1. Shows houses flooded

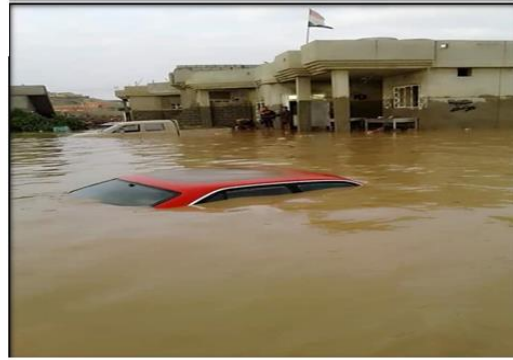
Picture 2. Water immersion level for homes

On 23/11/2018

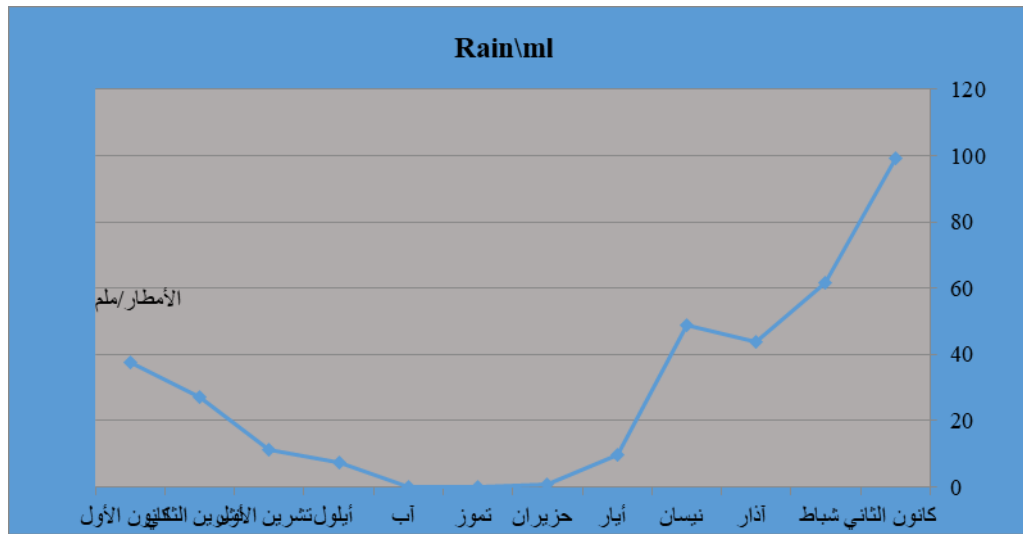
Figure 1. Rainfall Rates for Makhmour Station (1988-2013)

1. Climatic factors represented in the increase of rainfall, which amounted to more than 125 mm in hours, while the annual revenue of this region in previous years is approximately 200 mm, Table 7, Figure 1.

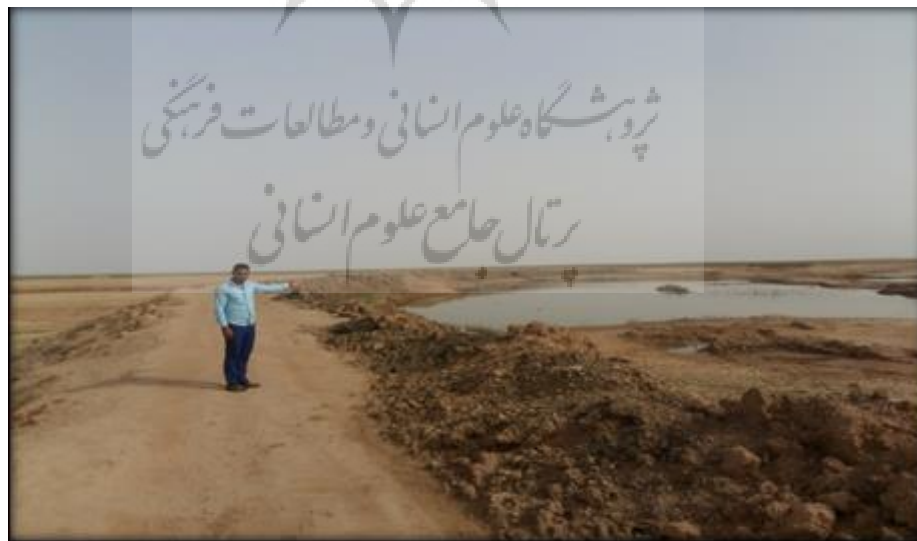
- 3. The collapse of the sand repayment in the top of the valley:** It is well known that the residents who are away from the permanently flowing watercourses resort to storing or harvesting water in different ways, especially those who are practicing grazing mainly as well as agriculture, through the establishment of dirt on the valleys to store water during periods of rain, for use in periods of interruption, The field study and spatial monitoring of the valley showed that the population groups make a dirt repayment on the course of this valley over a distance of (23) km from the sites of these villages are strengthening these repayment in the period of rain of each year, and because this repayment does not have drainage holes for excess water About the ability of these To repay to endure, the dam has collapsed The first one, including the water behind it, and the flow of water to the second dam, the second dam collapsed because of its inability to bear such quantities. To the west and to the fall of large amounts of rain in the southern and southwestern sections of Mosul. That (16.8%) Al-Khadraniya residents attributed the cause of the flood to this reason, while (21.6%) of the inhabitants of al-Houriyya blamed the cause of the flood to this reason. The study team believes that the cause of this flood is the reimbursement which did not have drainage holes for the surplus water. The answer does not weaken this reason because a large proportion of the inhabitants who were questioned do not know anything about these dirt repayments which were placed in the top of the valley.

Figure 1. Shows the earth dams built on the valley basin
