## **Rockfall hazard analysis in the Ganjnameh tourist area, west of Iran**

### **Abstract**

**Keywords:** Ganjnameh, rockfall, site investigation, weathering.

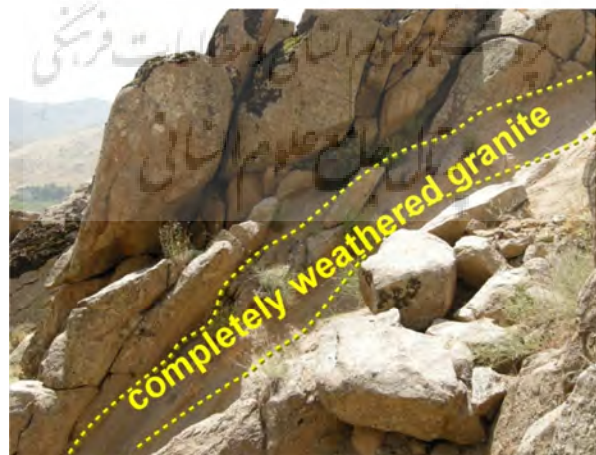
Fig. 5: Lying of instable blocks on completely weathered granite as basement.

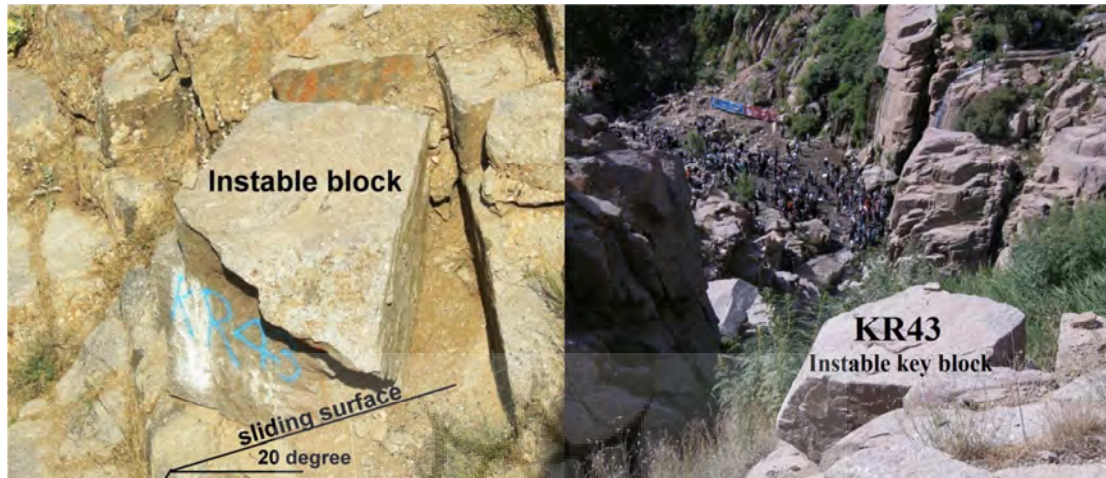
Fig. 6: A view of key block KR43 detaching due to Ice jacking action

The left side slope is in the shade most of the day, so that it will experience the least temperature variation during a day. So, snow will be thawed slowly, and the rocks on this side are in contact with water for a considerable time. Consequent to this condition is the development of weathering. As described, the main factors which play an important role in the left side instability are the high angle of slope and the development of a weathered basement. During rain, the shear strength of the weathered basement dramatically decreased and covered blocks will be detached from original lactation and moved toward the lower part of the slope. Inspection of right side zones indicated several sliding surfaces with the slope angle lower than the basic friction angle (Fig. 6). This means that the blocks will not be unstable just by the shear component of the weight vector, and external forces are

needed as well. The external forces are associated with ice-jacking phenomena. Right side slopes will attract more sunshine and are subjected to high temperature variations over 24 hours. During a day, sunshine leads to the thawing of snow and the water will flow in cracks and joints. In the evening and night, the temperature will drop to below zero and the water will be frozen. The generated ice can produce two pressures.

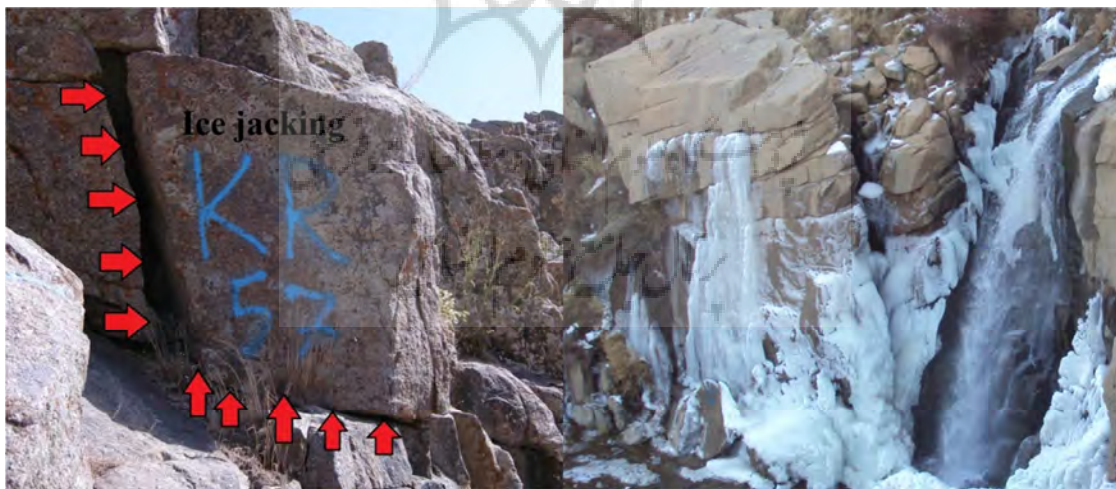
As is shown in Fig. 7, the pressures are perpendicular to the cracks and one of them, which acts on the sliding surface, leads to a decreasing basic friction angle. The other one applies additional shear forces, and both of them are playing instability roles. Also, repetition of the freezing-thawing cycles will make weak the rock strength and reduce basic friction angle due to fatigue action.

Fig. 7: A view of blocks detaching due to ice jacking action

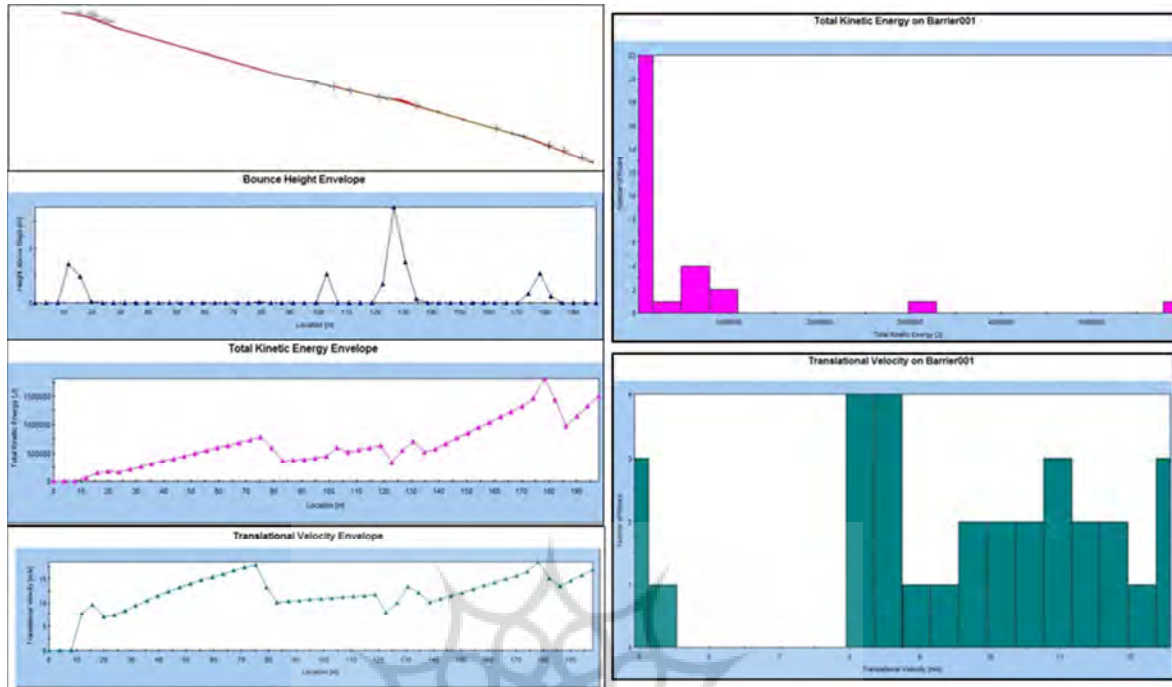
The obtained bounce height envelope from profile 1 located between zones 1 and 2, indicated that most of the blocks are moved in rolling on the surface and might bounce up to 2 m just after crossing the track road of Alvand mountain climbing (Fig. 8). The total kinetic energy envelope shows that this parameter is gradually increased during falling and at the near toe of the slope is reached around 1800 kJ. Assessing translational velocity changes shows that in two locations, reach to maximum value around 18 m/s. The falling blocks hazard will threaten the safety of visitors in the Ganjnameh valley and threaten the safety of Alvand Mountain hikers. Based on the three crucial parameters envelopes, 185 m from the cliff is a suitable point for performing barrier. It should be noted that the barriers must be placed in the most appropriate areas. The best location is there which has minimum bounce height and kinetic energy and also will support most of the falling blocks. Analysis of total kinematic energy on barrier shows that about 71% of the energy of the blocks is less than 150 kJ, 93% have less than 1000 kJ, one block has an energy of about 3100kJ, and another block has 6000 kJ kinematic energy. The translational velocity of blocks on the barrier was determined and the results indicate that just 4 blocks have a velocity less than 5.5 m/s, and the remains have a velocity in the range of 8-13 m/s.

Fig. 8: Summary of rockfall analysis results on profile 1

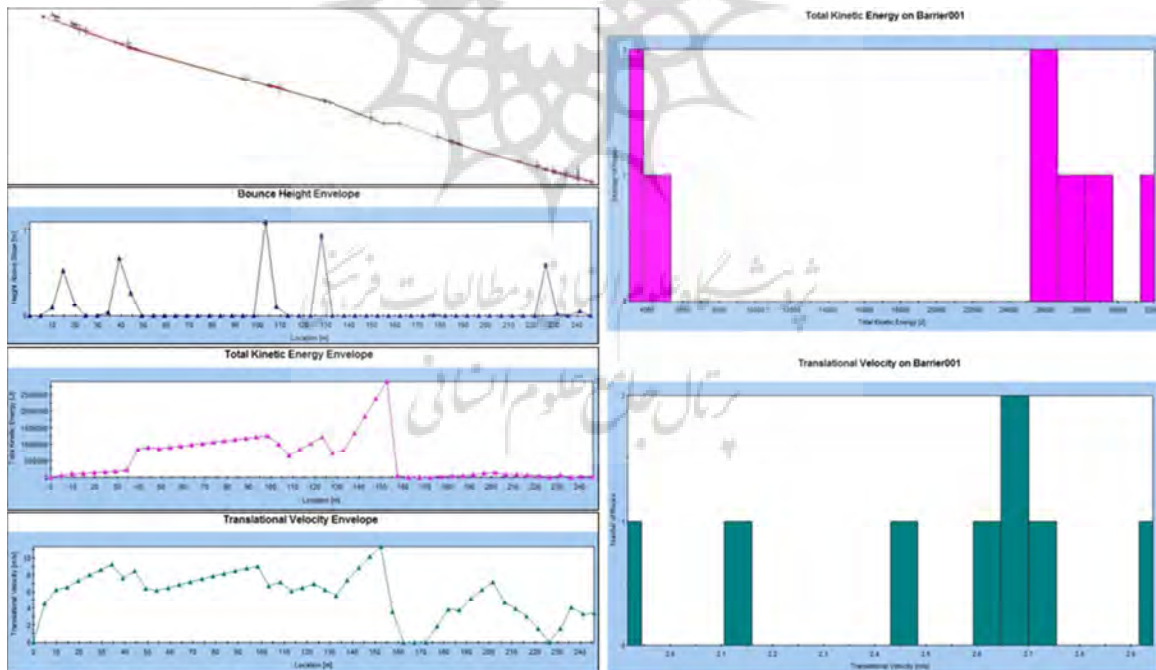
A summary of the rockfall analysis results of profile 2 located in zone 3 is shown in Fig. 9. This simulation illustrates that the falling blocks were moving in a rolling state and just in 5 locations show a little bouncing less than 1 m. Total kinetic energy variation more or less shows gradually increasing up to 155 m of the route and after that dramatically decreased. A close inspection of translational velocity changes in this zone indicates that this parameter more or less is varied similar to total kinetic energy.

Fig. 9: Summary of rockfall analysis results on profile 2

The velocity changes from 0-11 m/s, and a considerable decrease around 155 m of the route is highlighted. After crossing 220 m of the route, energy and velocity are sensibly decreased. On the other hand, the area is near the toe of the slope. So, the barrier location was considered at 228 m. assessment of falling blocks impact on the barrier indicates that just 8 blocks will reach the barrier.

The total kinetic energy of three blocks is less than 5 kJ, and the rest blocks energy is about 26-32 kJ. The translational velocity of the blocks at the barrier location varied between 1.9-3 m/s with a dominated velocity of about 2.6 m/s.
