Vulnerability Assessment of Buildings against Earthquake Case Study: Qadghoon Neighborhood, Borujerd, Iran

Original Article

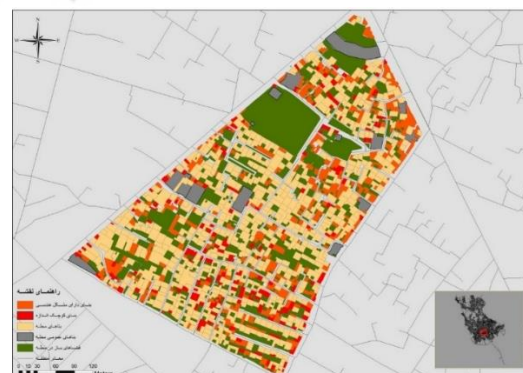
Figure 4. Locating buildings with geometric problems (authors)

The assessment of these buildings was based on three maps, namely the existence of asymmetries in the plot plan, the frequency of asymmetries in the block, and different forms of public buildings. Figure 1 depicts two types of buildings which were found in great numbers in this neighborhood. One group was the buildings with severe inherent geometric problem (According to the index explanations, the buildings which have irregular vertical and

horizontal dimensions and those that cannot tolerate the pass correction are considered geometrically irregular.) or that were problematic due to the corrections made after reconstruction processes, such as widening the carriageways. The second group consisted of small buildings, and consequently, of high vulnerability. Lack of geometric regularity and the smaller size (buildings with an area of lesser than 50 square meters including business and residential uses. See the table of extracted indexes.) of the building showed a complex seismic behavior that was much harder to be analyzed and predicted, compared to regular and simple buildings, which resulted in its higher vulnerability. On the other hand, these buildings confront the officials with greater difficulties (Due to the irregular structure which is in contrast with the regular structure of the reconstructed area and buildings, this issue causes an increase in the costs of the reconstruction process.) during the reconstruction process and cause a delay in reconstruction and a waste of resources.

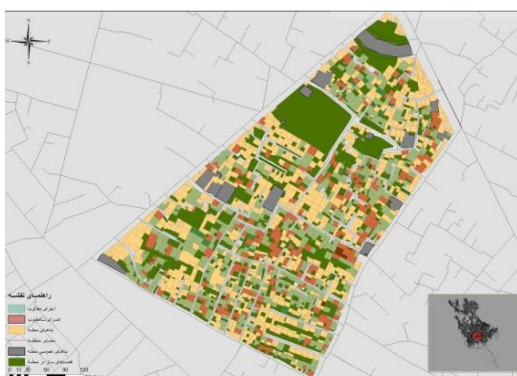
Figure 7. Locating of poorly constructed buildings (authors)

Weak construction remarkably enhances the amount of vulnerability during the earthquake. An increase in the number of losses and damages within the post-disaster time-span would double the amount of vulnerability. Figure 4 illustrates the buildings which were poorly reconstructed (the other hand, in addition to the present field

study, familiarity with construction conditions through life experience before the April 2006 earthquake in Borujerd and the presence of authors in this city, in the years after reconstruction and close observation of processes occurring, especially in the first years after the earthquake and the problems of this period, one of the most important of which was the lack of skilled and specialized personnel in the region, despite the high number of renovated buildings in this period, shows an intense decrease in the quality of construction in this period) after the earthquake due to several reasons, such as a lack of consistent and careful supervision of the reconstruction and/or an absence of expertise among the members of the reconstruction teams. These buildings incorporated 34% and 16% of the newly constructed and the total number of buildings in this area, respectively. Such statistics indicate the low-reliability coefficients of the newly constructed buildings and extensive waste of reconstruction budget. Overall, the vulnerability number in this index was obtained at 4, which was high.

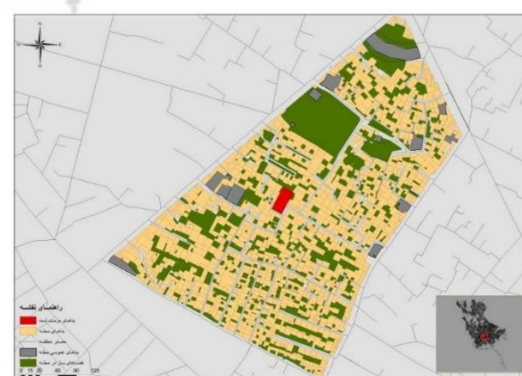
Figure 8. Locating restored building (authors)

Along with the preservation of the heritage and identity of the land, restoration of historically valuable buildings would decrease the vulnerability of the area during the disaster. Additionally, protecting these buildings via restoration would increase the possibilities of future developments by tourism enhancement and plays a highly direct role in controlling poverty within the area. Although extensive restorations have been carried out during the reconstruction of the area, Figure 4 shows that 5% of the whole buildings in this area

are made of brick (with a frequency of 64 buildings), most of which have architectural and identity values. Since only one out of all buildings was restored (See the zoning map of the restoration of the area or the locating of the restored buildings), the vulnerability number was estimated at 5, which was very high.

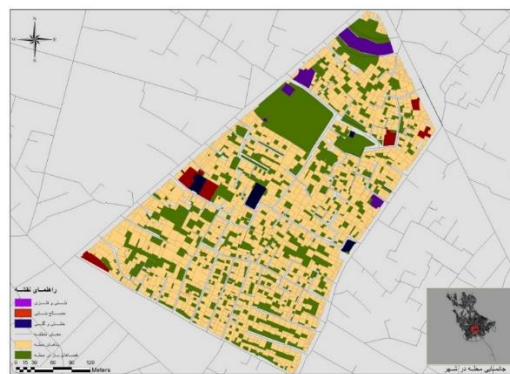
Figure 10. Locating types of construction technology (authors)

The score of this index was extracted from two maps of private and public buildings of the area. If the vulnerability of the structures of the buildings within the area decreased, fewer losses would be experienced during the disaster. That is why it is believed that this index has a higher influence on vulnerability at the time of disaster. Based on the investigations of the area, the highest frequency of the type of construction materials was obtained for construction materials with 49%, followed by concrete and metal structures with 46% of the whole buildings. The least frequent structures were related to the traditional structures made of bricks with a 5% frequency. Since those structures constructed with building materials were not restored and did not perform well during the seismic shocks, along with the high number of poorly constructed (See the map of locating the poorly constructed new buildings) new buildings and also brick structures that were not restored (See the zoning map of the area restoration or the locating of restored buildings), the vulnerability score of the neighborhood in this respect was calculated at 3.59, which was considered average to a relatively high rate.

The effect of the high vulnerability score of public buildings is more obvious in different stages of the earthquake especially the post-disaster stage. In this area, 33% of the whole public buildings were made of concrete and metal structures, and therefore, had low vulnerability against the earthquake. However, the structures made of building materials with a frequency of 40% had the highest score among the public buildings. Moreover, 27% of the public buildings were made of brick, indicating a very high vulnerability index. These buildings should be restored and reconstructed before the occurrence of other disasters. The score of vulnerability in this respect was estimated at 3.61, which was average to relatively high. Overall, the
